# Stress to Failure Testing of Pressure Vessels with SHM Sensors at Liquid Nitrogen (LN<sub>2</sub>) Temperature

# NASA's Automated Propellant Loading

**Objectives of Testing:** The purpose the Structural Health Monitoring (SHM) sensors for Automated Propellant Loading is to develop a sensory system that can assess the fuel tank that is all composite. The system must be able to monitor the tank from post inspection to the point of operation. These systems will provide engineers with a quick assessment of the structural integrity without having to perform another lengthy NDE inspection. *Sensors system must be able to withstand harsh cryogenic environment during fill cycles.*

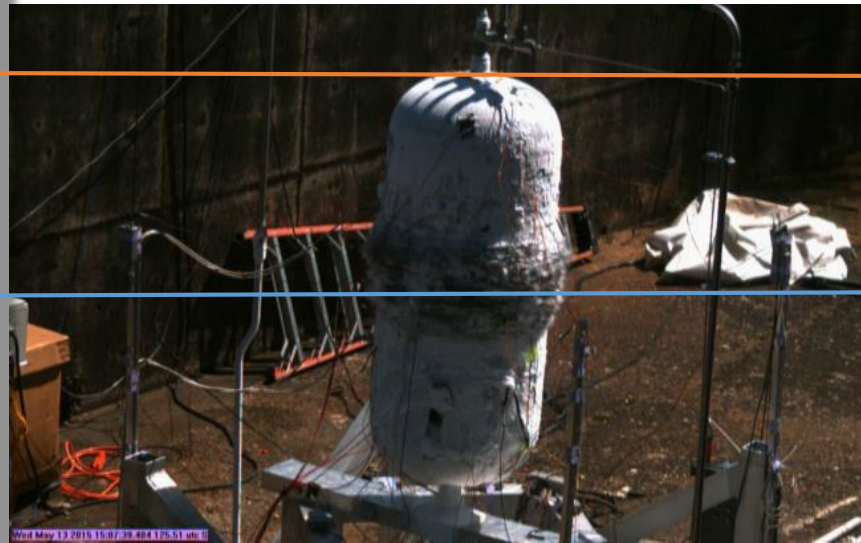
Damaged overwrap

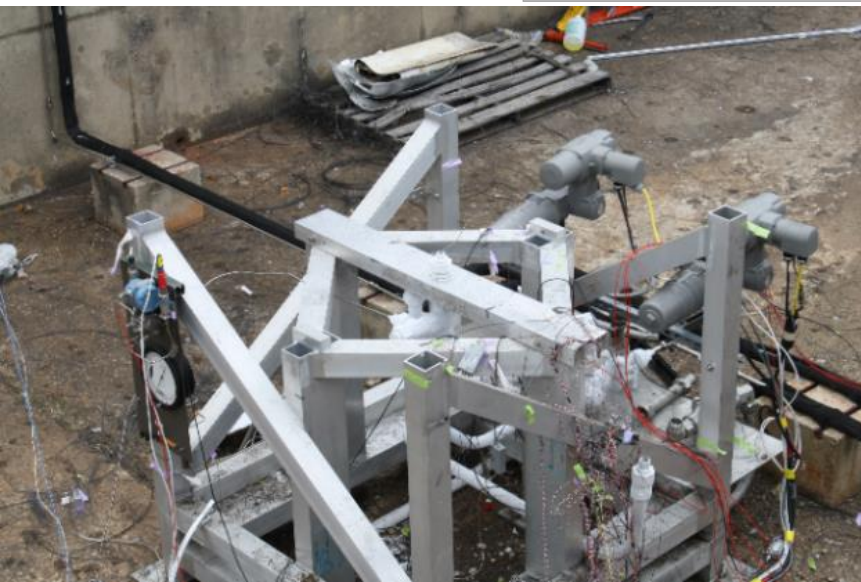
COPV 2 Burst at 3370 psi below the center. It was launched several feet in the air and landed about 350 ft. away.
